#### Human Impacts to Coastal Ecosystems in Puerto Rico (HICE-PR):

A remote sensing, hydrologic, ecologic, and socioeconomic assessment with management implications.

#### NASA IDS Grant: NNX14AJ23G

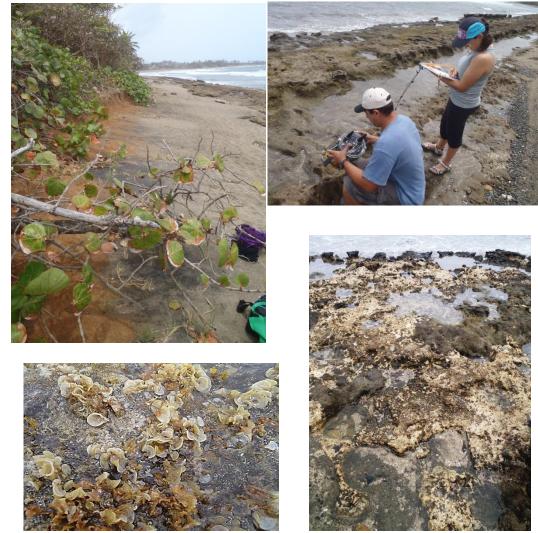
## Beach geomorphology and spectral analysis of beach components

- Side project of HICE-PR (Irma Caraballo's PhD Thesis)
- Spectral characterization of beach components from the vegetation line to the swash zone
- Sediments show river influence (dominance of magnetite and terrigenous near river mouth)
- Found remanents of a relict reef in the swash zone intermingled with beach rock and eolianite
