Rota - Talakhaya Watershed & Conservation Area

Talakhaya Revegetation Project

Quantifying Our Efforts: Monitoring

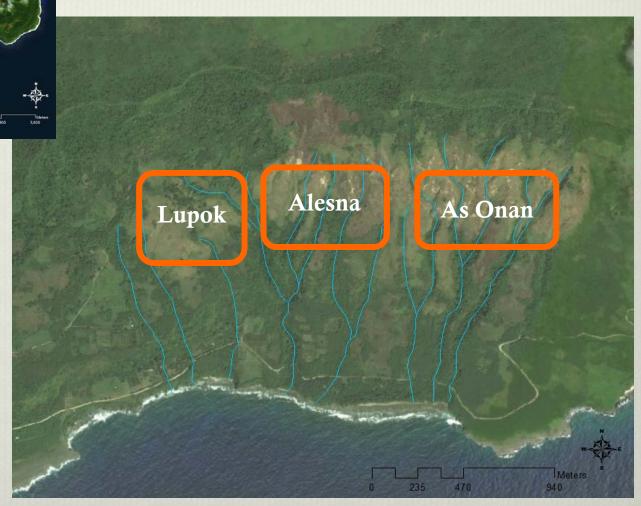
Project Phases

Phase I = As Onan*

Phase II = Alesna*

Phase III = Lupok

*most critical

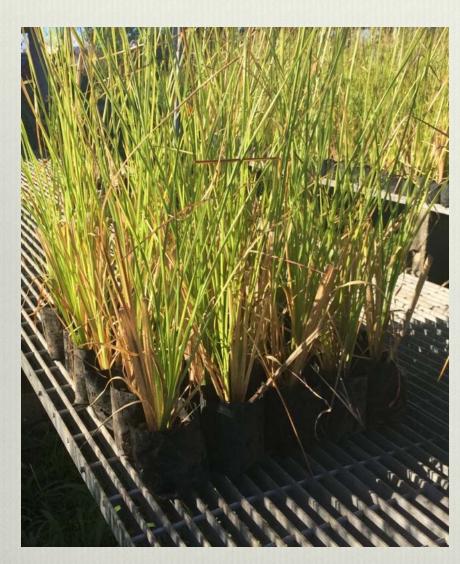
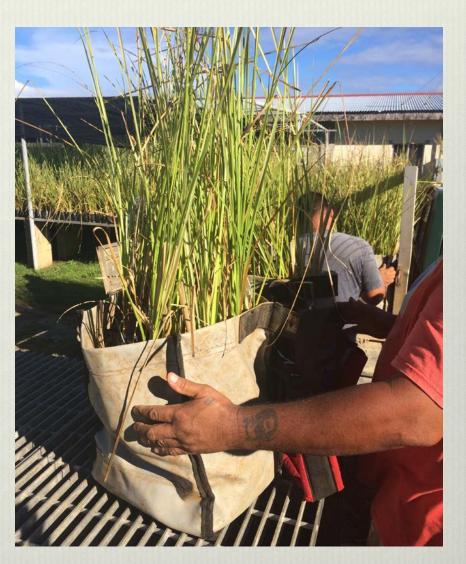
Wonder grass introduced in 2009

Vetiver Grass - Vetiveria zizanioides

- Establish critical areas first
- Species focus:
 - Grasses = Vetiver grass (wonder grass) and Bahia grass
 - Trees = Acacia confusa (non-native)
- Plant grasses on contour/elevation lines top to bottom to avoid damage
- Plant vetiver in single rows with 1 ft spacing
- * Between rows plant:
 - Bahia grass at 1-2 ft spacing
 - Acacia 2-3 ft. above row of vetiver at 6-12 ft spacing
- Plots assigned GPS points
